Report of Investigation in
the Matter of Sinking of
Passenger Vessel EXPLORER (O.N. 8495)
23 November 2007
in the Bransfield Strait near the South Shetland Islands

**26 March 2009
Monrovia, Liberia**

Report of Investigation into
the Sinking of
Passenger Vessel EXPLORER
23 November, 2007
in the Bransfield Strait near the South Shetland Islands

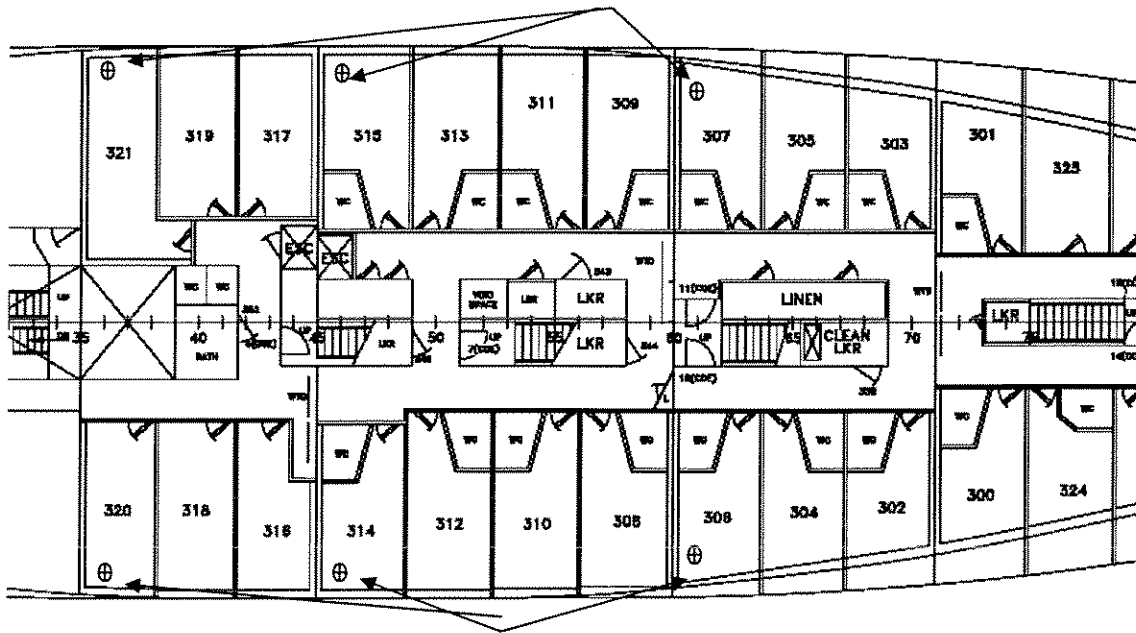
As indicated in Graphic 5, there were six ducts below the bunks or settees. The devices consisted of a plate with a spring-loaded hinge on one side of the plate that kept the plate in a closed position until the water level in the passenger cabin reached a certain level. The weight of the water would cause the plate to open and water would drain into the Engine Room. The Chief Engineer stated that the engine crew had to periodically perform maintenance on the hinges, usually after hearing complaints from the passengers. The sewage treatment tanks were located in the engine spaces and would vent gas and create an unpleasant atmosphere in the passenger cabins if the plate was not completely closed.

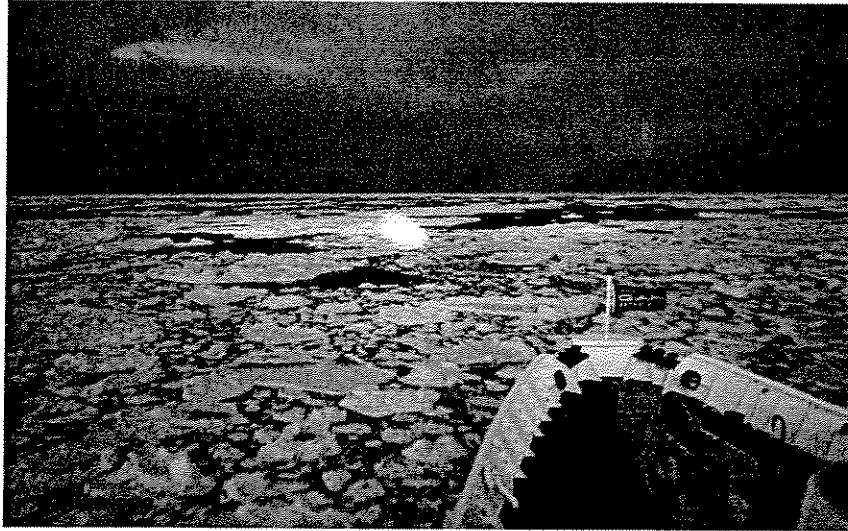
Date 23/11/07 Time: 3:27 Taken from the Bridge. First picture of ice flow.
